BATTERY MONITORING…3 SHORT STORIES

Gary J. Markle, Director of Marketing, BTECH, Inc. Whippany, NJ USA

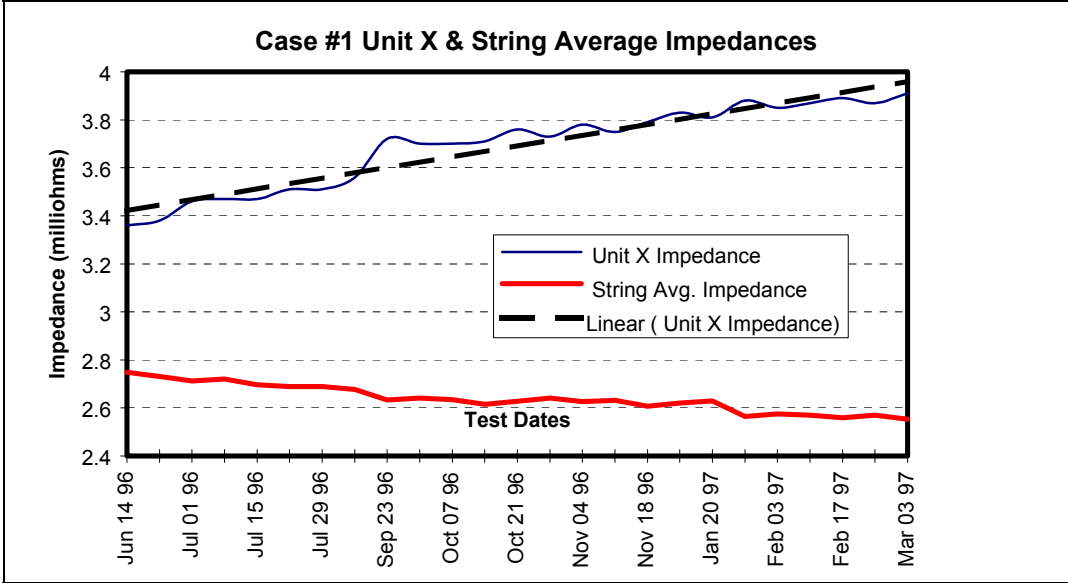
This particular 6-cell monobloc battery (#64) has exhibited higher impedance than normal since the monitor was installed. (See figure 1.) Unfortunately battery monitors seldom make a suspect cell any better. They may point to environmental and conditioning factors but once a cell is in its downward spiral of life, there is only the reporting of degree. The owners decided to utilize the slope level alarm since the suspect monobloc already passed through the critical transition alarm set for the battery string. The resultant Figure 1 illustrates the trend of impedance for unit 64. As of March 3, 1997 the unit consistently alarms as a slope value of 10 $\mu\Omega$ per week is exceeded and the value was 35% above its critical limit. Interpreted, this means that it is 45% above the impedance for a new jar, 2.5 $\mu\Omega$. Since the battery manufacturer has graciously agreed to replace the defective unit at the 50% point, and the trend is safely linear, a new unit ordered based on the information provided by the battery monitor.

***Figure 1***   **Case 1:   Unit & String Average Impedance**

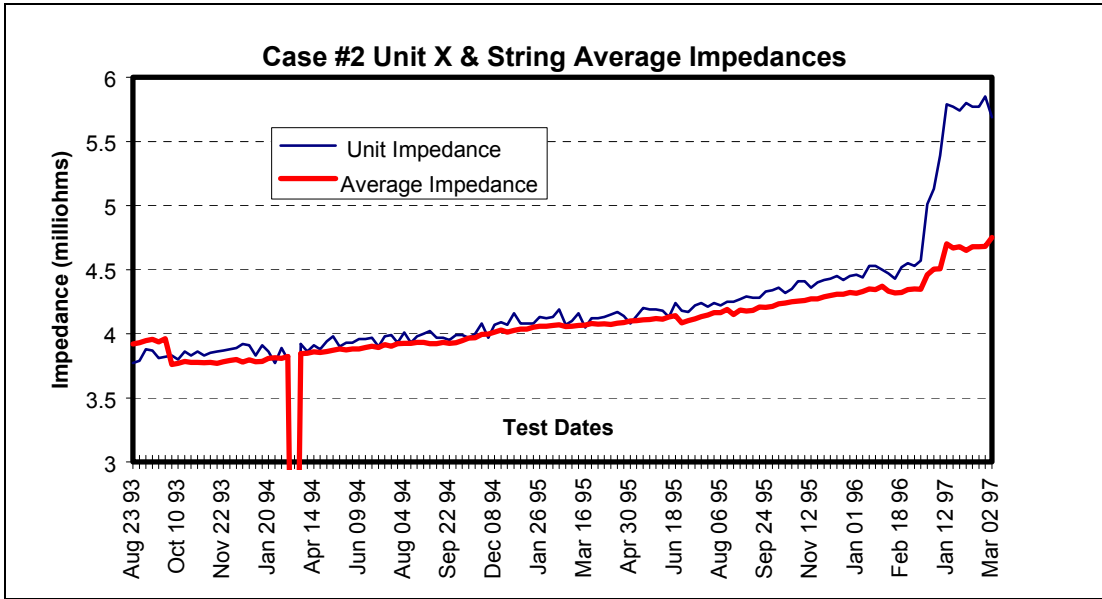
Float voltage performance of this monobloc has been stellar with no recorded deviation from ideal (13.65vdc). The only discharge history was from a two-minute outage in 1994. Because of the criticality of the site and power system, the units do not have any load test history other than acceptance testing. The harsh reality is that this is the typical working situation in which batteries and their monitors need to exist. As expected, over the lifetime of the battery string, the impedance values would rise as the cells age. This is normal as the cells age, dry out and/or lose capacity. The string average of impedance values parallels the unit impedance performance shown in Figure 2. The negative excursion in February of 1994 was caused by a blown fuse in the monitor.

The graph in Figure 2 points out the benefit of utilizing the slope method of alarm as unit 45 slowly diverges from the string average and rapidly accelerates at a rate of over 25 $\mu\Omega$ per week, whereas months prior to this excursion, the unit was below the alarm threshold in average mode and only creeping

up at an 8 $\mu\Omega$ per week rate. The decision to await battery replacement had been made under similar considerations as in Case 1 but had to be re-evaluated after the impedance excursion in July of 1996. External connections were checked in order to eliminate non-cell related causes for the rapid rise in impedance. These could include dirty or loose cell connecting straps or corrosion on the posts. All was found to be in order and it was concluded that the jar had diminished conductivity due to plate separation from the electrolyte. Because of the similarity in trending among all of the monoblocs within this battery system and the age of the jars, the decision was made to replace the entire battery.

Figure 2   **Case 2: Unit and String Average Impedance**

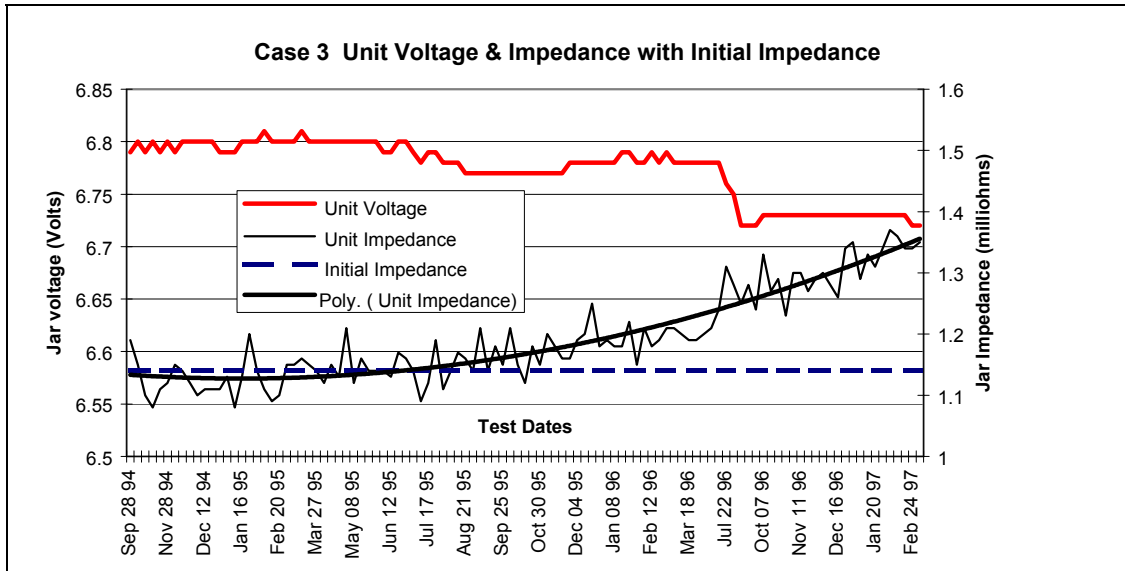
The introduction of monitoring slope variation to the observer software proved useful to this customer and was added in the fall of 1996. Figure 3 shows the life cycle of this particular 3-cell monobloc, which has exhibited variations in voltage and impedance parameters. The dotted line represents the initial value determined at the time of monitor installation. As with new cells, the impedance value moves about in the infant stages of battery formation, usually settling to a value below that recorded at inception. This battery unit exhibited such a profile and developed a positive trending a year later.

Because of the wide alarm limits for both voltage and impedance, any transitions would be neglected for a long period of time. Fortunately, the delta alarm for impedance was set quite low at 5 $\mu\Omega$ per week and the impedance increase was noticed. Unfortunately, the attached UPS repeatedly took an energy bite from the batteries and created fluctuations in the weekly impedance readings because of state-of-charge influences. But the polynomial trend line shows a positive climb.

Although the last recorded impedance value only represents an eighteen percent (18%) shift, the delta alarm actually placed a spotlight on the unit's voltage performance. The manufacturer's float voltage swing is $\pm$ 0.10 volts per cell and would produce a unit float range of 7.08 to 6.48 volts. The last float voltage level of 6.72 is far from the set minimum but an indication of trouble ahead is recognized. And this is the benefit of battery monitoring with forecasting capability. As this customer approaches his one chance for maintenance per year, he can assimilate the data provided and determine his odds for

Figure 3   **Case 3: Unit Voltage & Impedance Performance**
